# Home Survival in Wildfire-Prone Areas: Building Materials and Design Considerations

**STEPHEN L. QUARLES**, UCCE Natural Resources Advisor, Contra Costa County; **YANA VALACHOVIC**, UCCE Forest Advisor, Humboldt County; **GARY M. NAKAMURA**, UCCE Area Forestry Specialist, Shasta County; **GLENN A. NADER**, UCCE Natural Resources Advisor, Sutter-Yuba Counties; and **MICHAEL J. DE LASAUX**, Natural Resources Advisor, Plumas-Sierra County

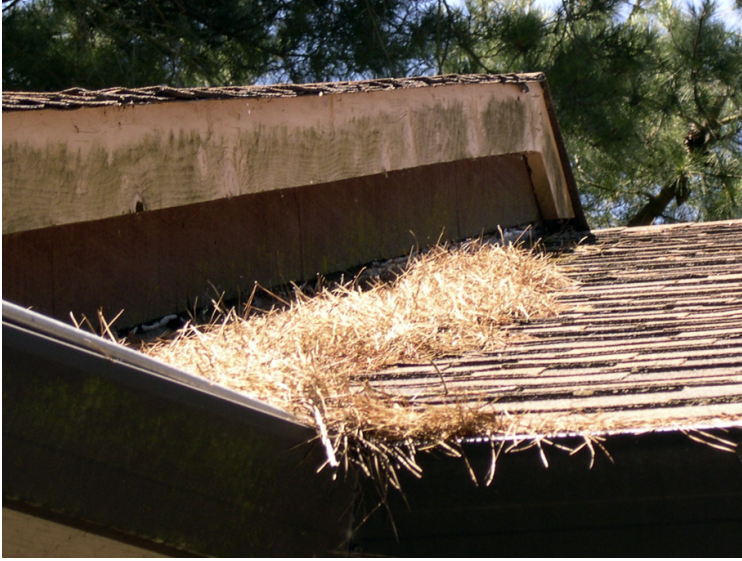
**Figure 5.** Vegetative debris accumulated at this roof-to-wall intersection. Ignition of this debris would expose the adjacent siding to flames, as well as the underlying sheathing above this stand-alone Class A roof covering. Depending on the overall roof design, the Class A roof covering could give the homeowner a false sense of security. *Photo:* Stephen L. Quarles.

A complex roof provides an additional level of vulnerability. The term *complex* indicates that there are a number of horizontal-to-vertical intersections on the roof that could make a Class A roof more vulnerable to wildfire, and in particular to an ember exposure. From a fire performance perspective, these intersections provide collection points for windblown debris (e.g., pine needles and other vegetation), debris from overhanging trees, and—during a wildfire—windblown embers. These locations are also where different construction materials with different fire vulnerabilities will be present on the respective surfaces. If ignited, the flames from the burning vegetative debris would provide a flame contact exposure on the siding material, the roof sheathing or soffit material, or even a window. The vulnerability of these components will depend on material selection and other design considerations. Particularly with a Class A roof, it will be the fire resistance of the siding, sheathing, or window that will determine the vulnerability of the complex roof, not the roof covering itself. Examples of two complex roof features that can increase the vulnerability of a complex roof are given in [figures 5 and 6](#).

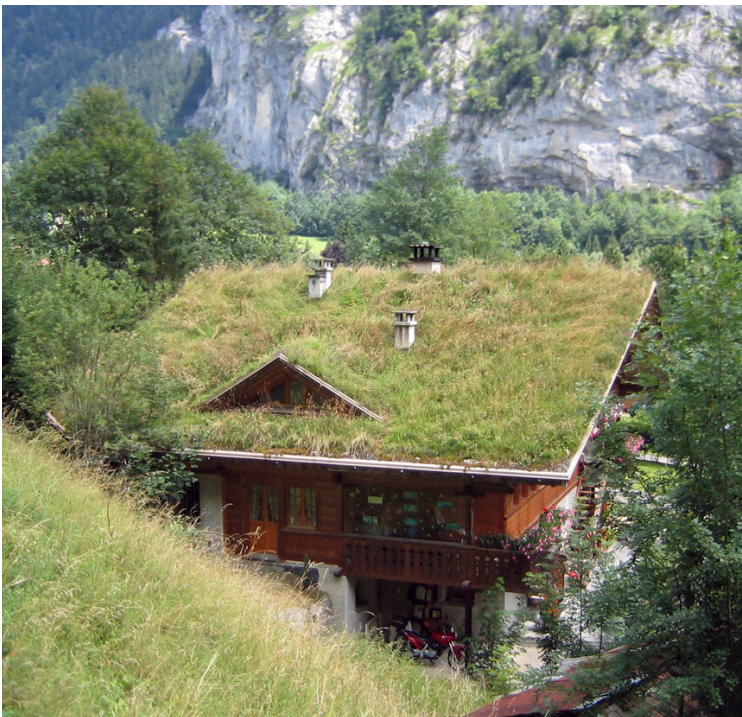
**Figure 6.** This vegetative (green) roof covering provides Class A protection in terms of fire penetration into the attic or living space, but ember ignition and subsequent flame spread and contact with the dormer and window shown in this photograph could result in the glass breaking and fire entering the building. *Photo:* Bernard Harrison.

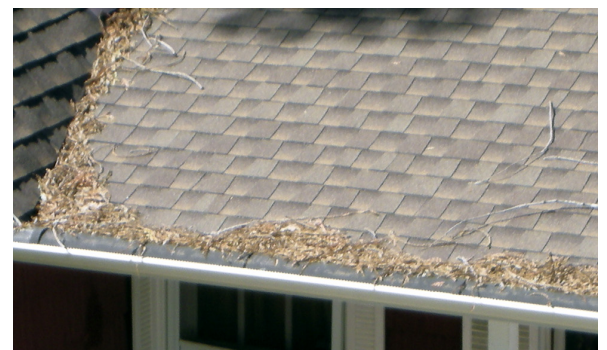
**Figure 8.** Debris accumulation behind a gutter cover device. The gutter is clear of debris, but the roof still should be cleared of debris. Photo: Stephen L. Quarles.

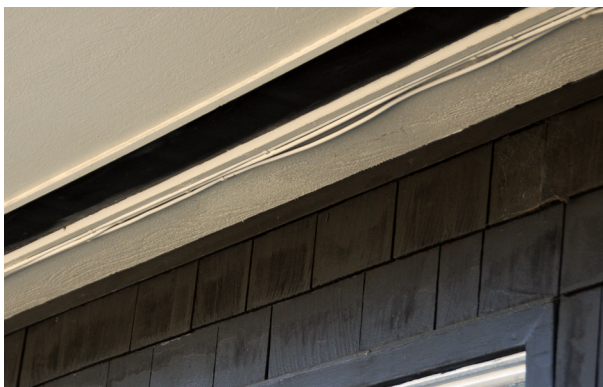
**Figure 14.** An example of a soffited eave, also sometimes called a *boxed-in* eave. Depending on the vulnerability of the vent, embers could enter into the soffit area. Vertical flame spread up the wall would make flame entry through the vent and into the attic more likely. Moving the vent away from the wall (closer to the edge of the roof) would make flame and ember entry less likely. Photo: Stephen L. Quarles.

be cut into the blocking. The second is a soffited construction where the eave is enclosed (fig. 14). This type of construction is also called a *boxed-in* eave, although boxed-in is sometimes reserved for situations where an open-eave design is enclosed, following the slope of the exposed rafters. The vulnerability of an unvented open eave or soffited eave construction will depend on the material and joints. Joints that exist between different pieces of building material are particularly vulnerable in combustible soffit material, and they will usually be the location where the fire would enter. For example, the initial failure in a tongue and groove (T&G) soffit material will either be at the T&G joint or at a knot. A knot or internal void in a plywood soffit material would be the likely failure location (Jennings 2000). Joints would also be the most likely failure location in a noncombustible material.

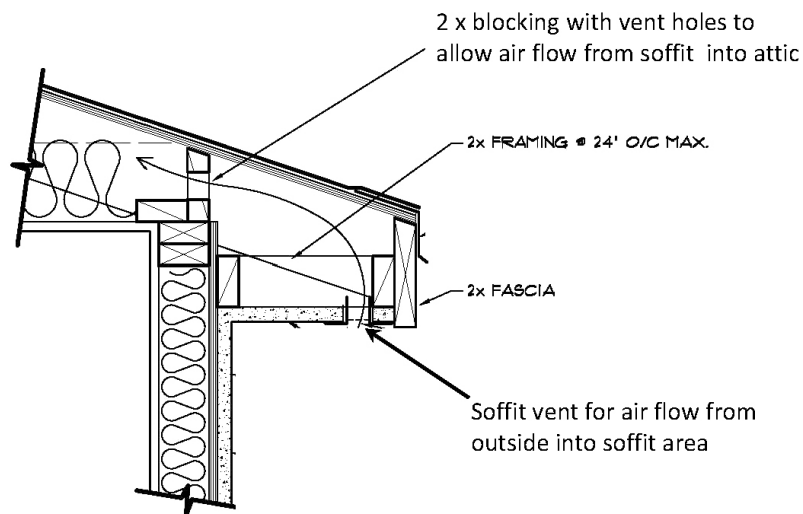
**Figure 15.** Diagram of construction details that allow air to flow from the soffit into the attic. Source: Adapted from *Ignition Resistant Eave Construction Guidance Document*, courtesy of San Diego County Department of Planning and Land Use.

ings in order to provide the circulation necessary to ventilate the attic (fig. 15). The California Building Code restricts the use of some types of vents in the eave area.

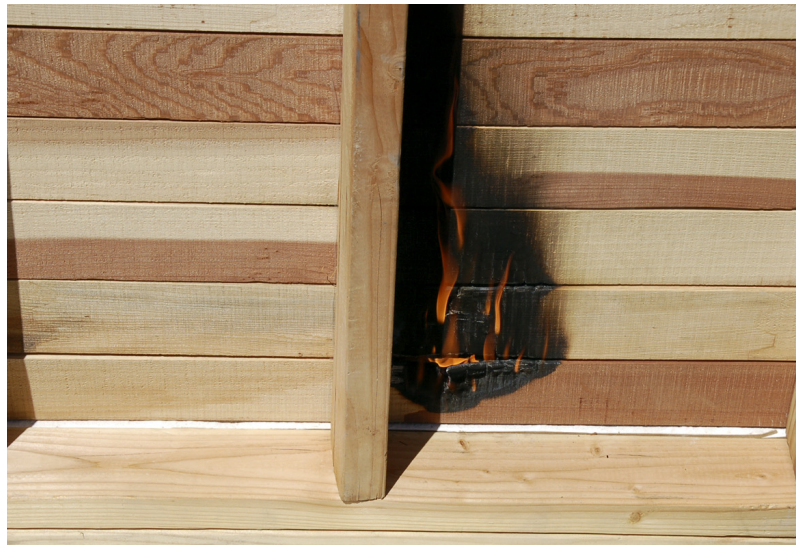
**Figure 18.** Flame penetration (*burn through*) at the rabbeted bevel lap joint in a solid wood siding product, as viewed from the stud cavity side of the wall. This test was conducted at the UC Fire Research Laboratory. Although a panelized sheathing product is commonly used in construction, it was not used in this test in order to allow viewing of the siding performance. Use of sheathing has been shown to increase the time needed for fire to penetrate into the stud cavity, sometimes to the point of excluding entry altogether. *Photo:* Stephen L. Quarles.
